PLUM CREEK RESTORATION WORK

February 2018

PLUM CREEK ENVIRONMENTAL MITIGATION SITE

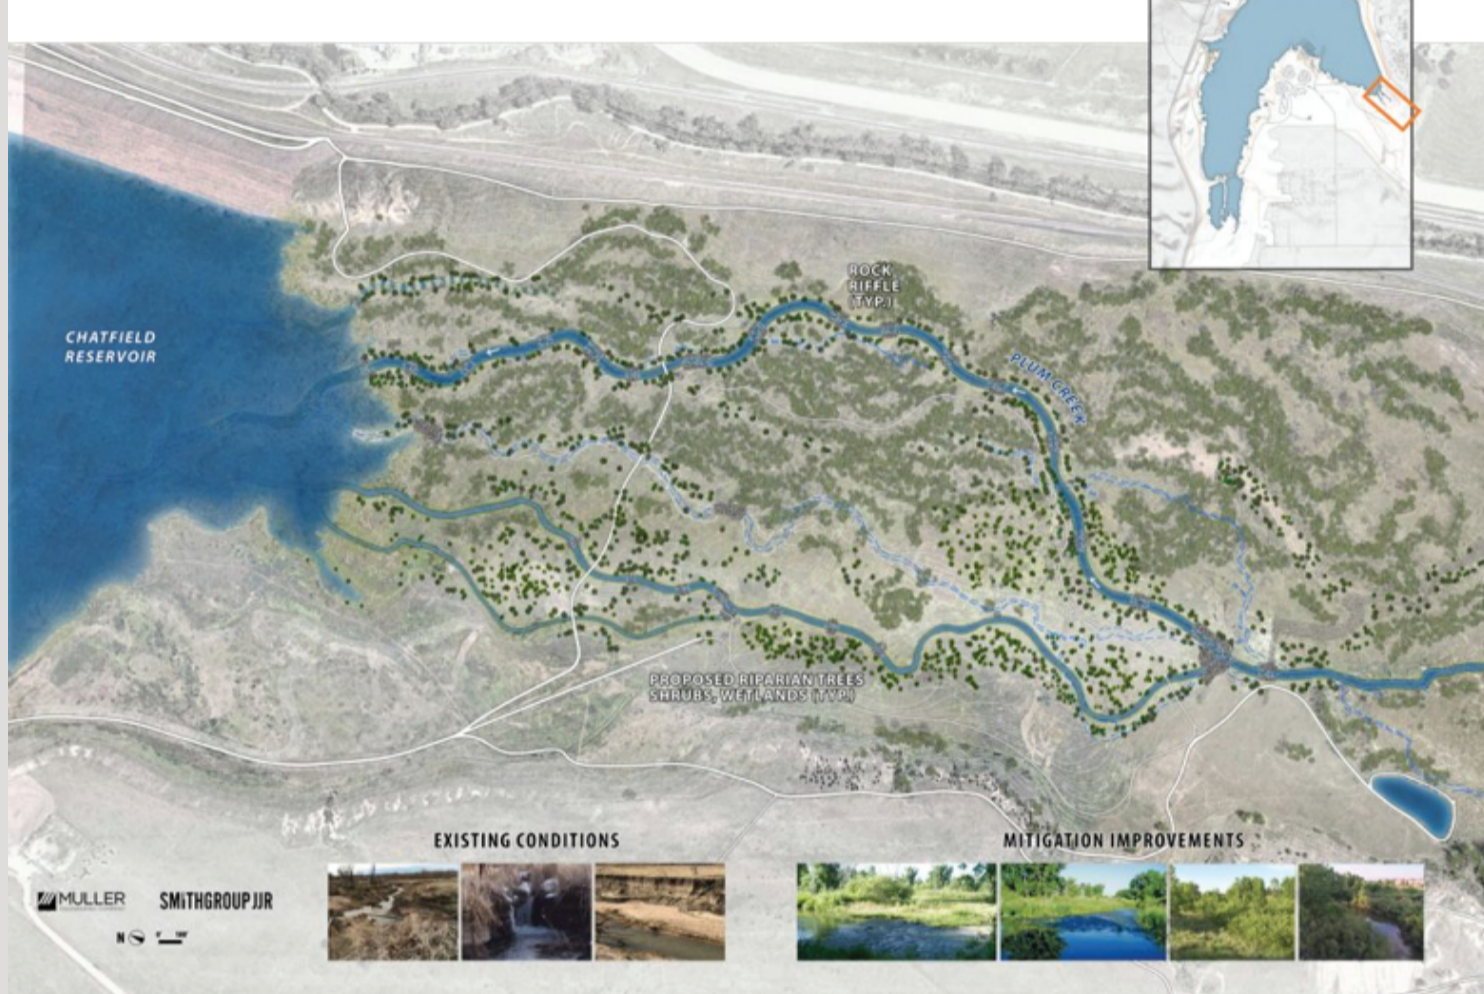
When the CSR was approved by the federal government, it also garnered support from the state and a wide variety of local entities as well as NGOs. Further, the Colorado Department of Natural Resources serves as the non-federal sponsor for CSR. Two of its divisions, the Colorado Water Conservation Board (CWCB) and Colorado Parks and Wildlife (CPW), are participating in the project. CWCB is an important funding and policy agency, and CPW has ownership of state park functions as well as the state mitigation planning efforts in accord with Colorado law (C.R.S. 37-60-122.2). The 122.2 plan calls on the participants in the CSR to undertake significant mitigation to compensate for "potential adverse effects to the fluctuation zone." Included in the plan is a commitment for millions of dollars for Plum Creek restoration as discussed above (see map for project area).

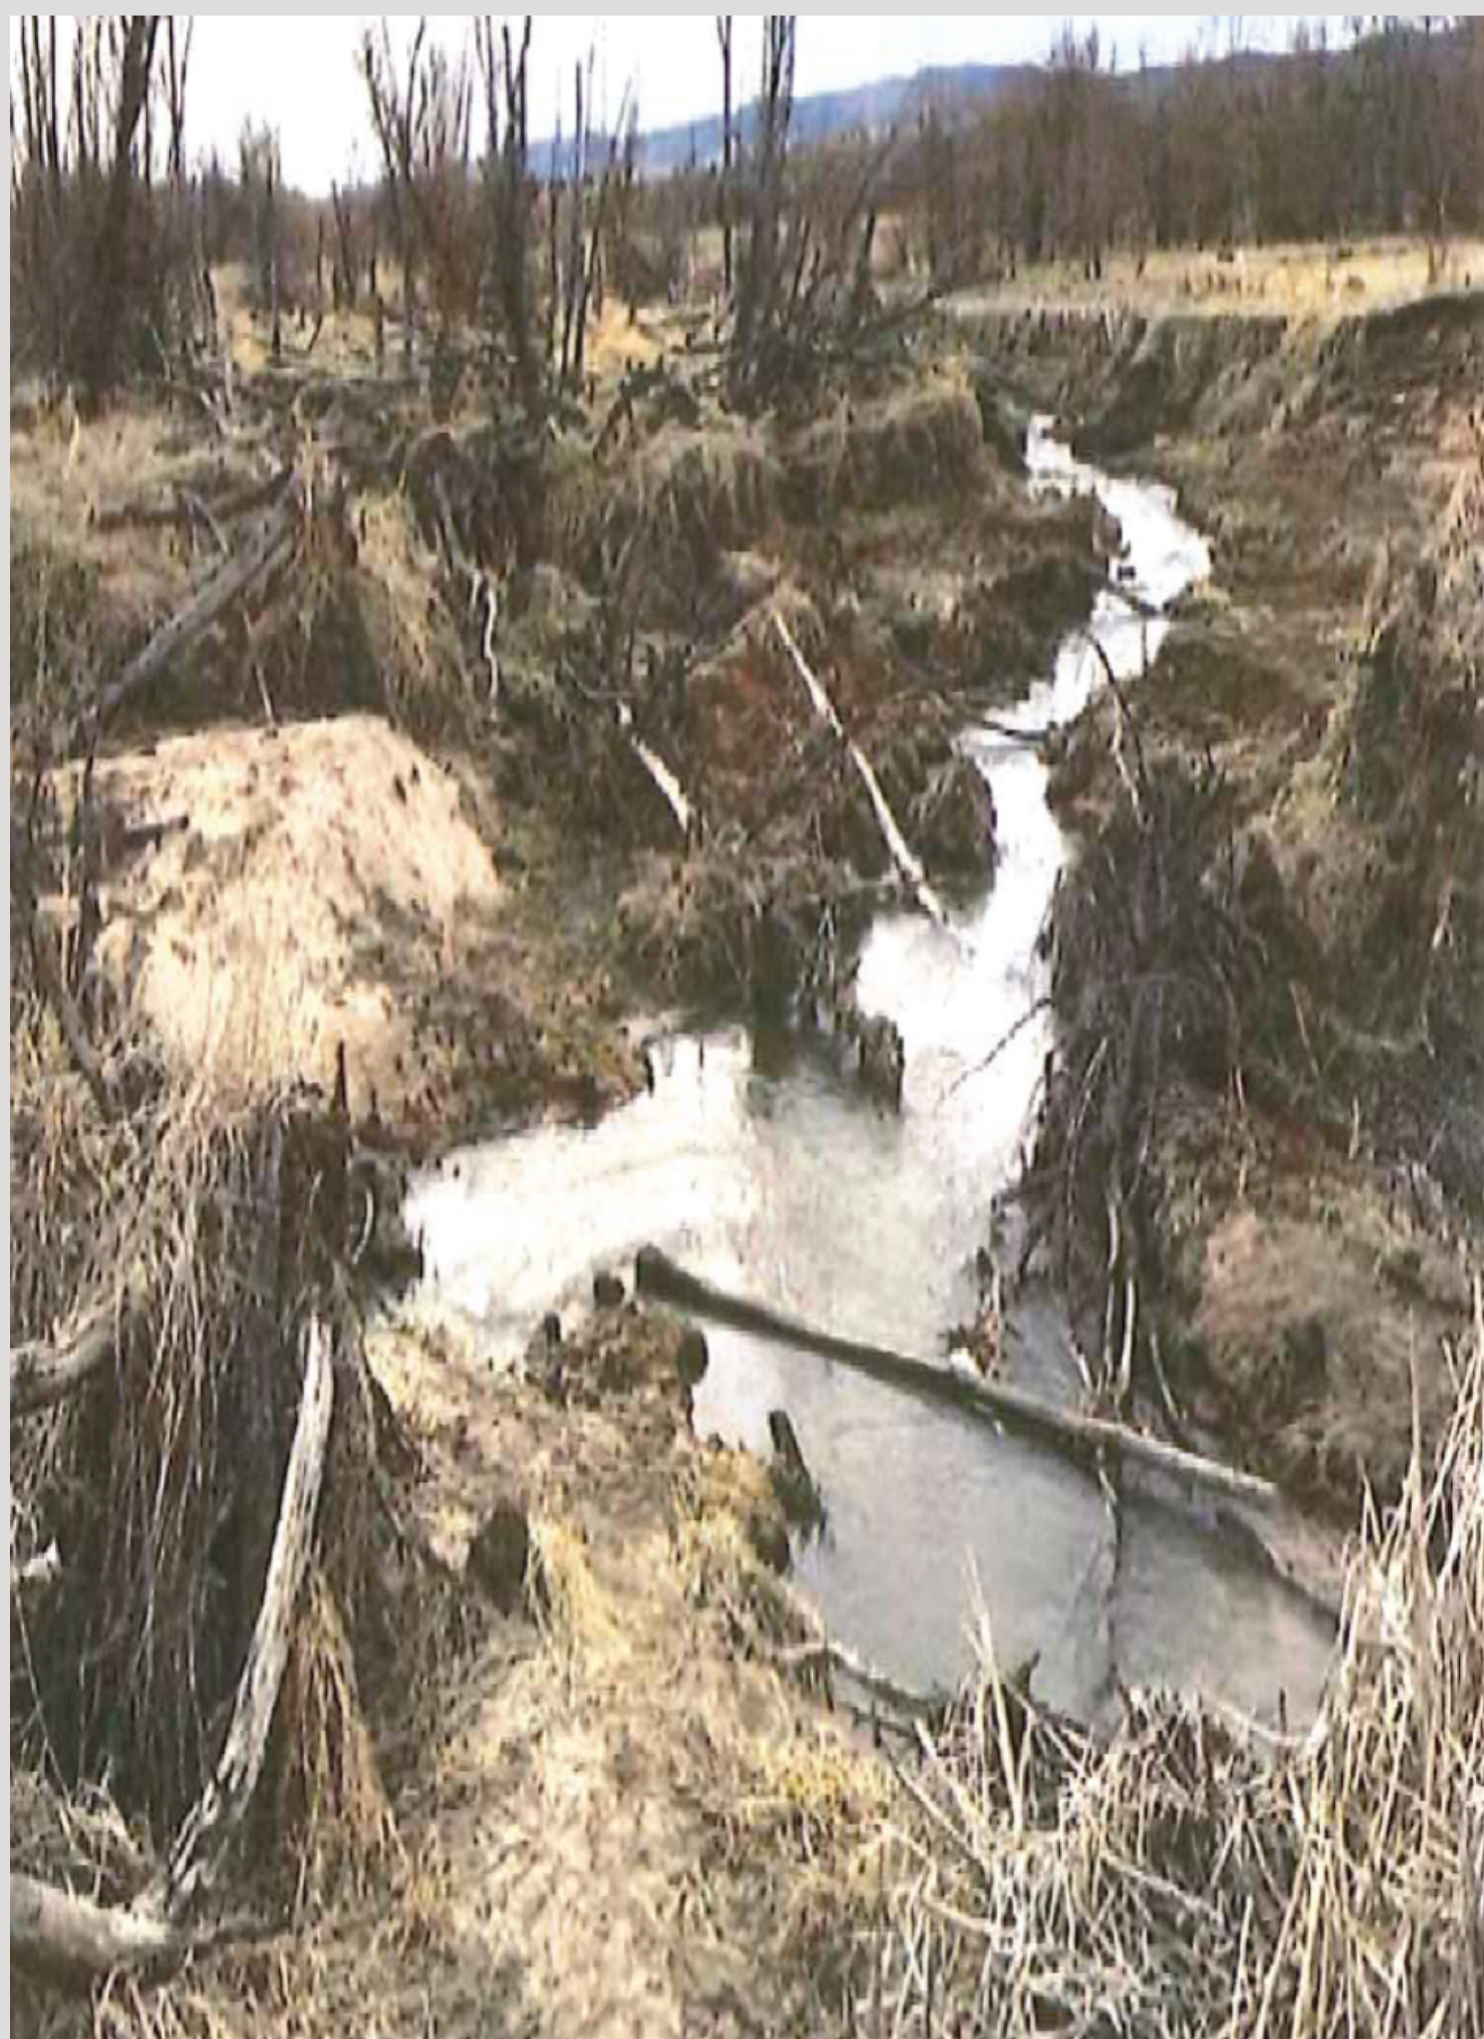
The Plum Creek corridor, from the new higher water level of the reservoir, upstream approximately 7,000 feet, will be stabilized by raising the multiple stream bed sections and constructing riffle-pool rock structures to control longitudinal grade and planting of riparian and wetland vegetation to control erosion and provide habitat.
