The Restoration of Plum Creek

In November of 2017, following the thorough vetting of the design plans prepared by Muller Engineering, Inc., Concrete Express, Inc. (CEI), along with its sub-contractor Western States Reclamation, Inc. (WSRI), were brought on board to construct the Plum Creek On-Site Environmental Mitigation Project, within Chatfield State Park.

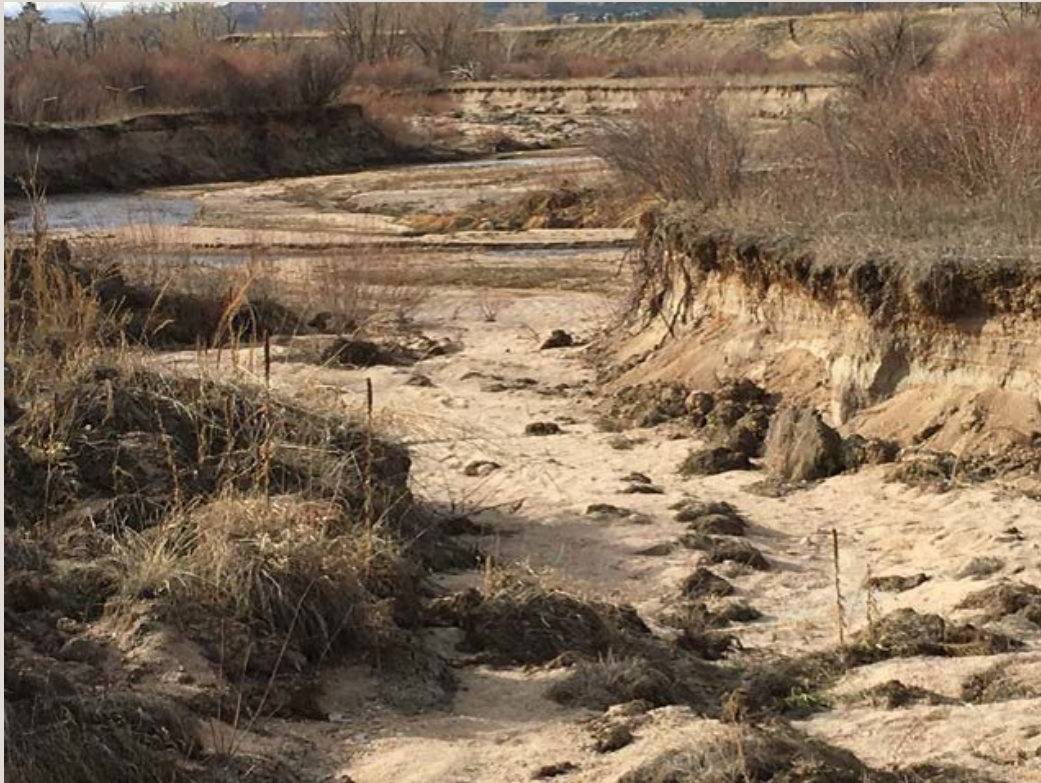
Widespread erosion was evident on Plum Creek throughout the Chatfield State Park reach prior to the implementation of this project.

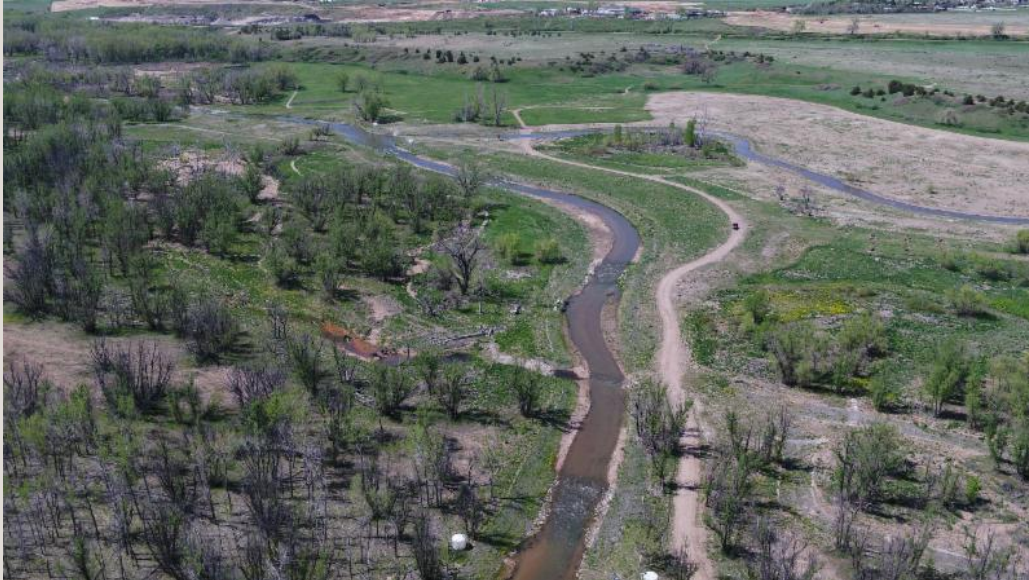
Aerial view of the completed Plum Creek main channel work showing several riffle-drop rock structures installed to eliminate erosion and channel degradation.

Included in the civil work performed by CEI, Plum Creek's main channel was relocated back to its historic location. Several riffle-drop rock structures were installed to control longitudinal grade and to prevent head-cutting erosion and channel degradation. To protect the main channel should there be future flood events, secondary overflow channels and bank control structures were built within the floodplain.

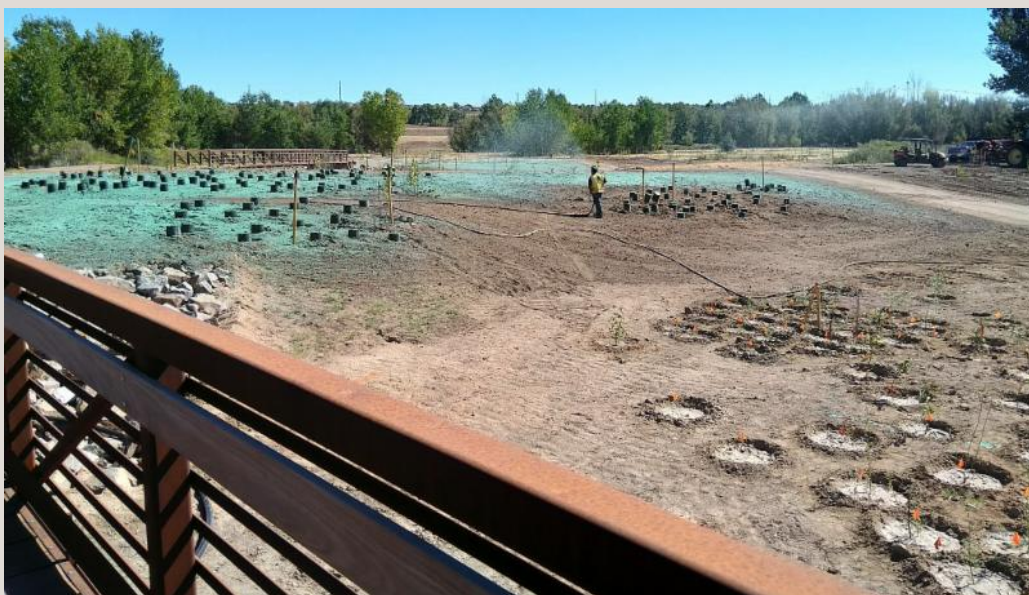
Installation of native trees and shrubs required application of seeding and hydro-mulching and daily hands-on watering.

Upon completion of the civil work, WSRI planted over 54,000 native trees and shrubs, along with seeding and hydro-mulching of nearly 100 acres. Approximately 63,000 square yards of coir mat (a woven natural fiber blanket) was also installed as bank protection, which will greatly reduce erosion along stream banks. A team of ecologists carefully analyzed plant species, locations and depths within various hydrologic zones to ensure the highest level of survival and creation of a diversified, sustainable environment.

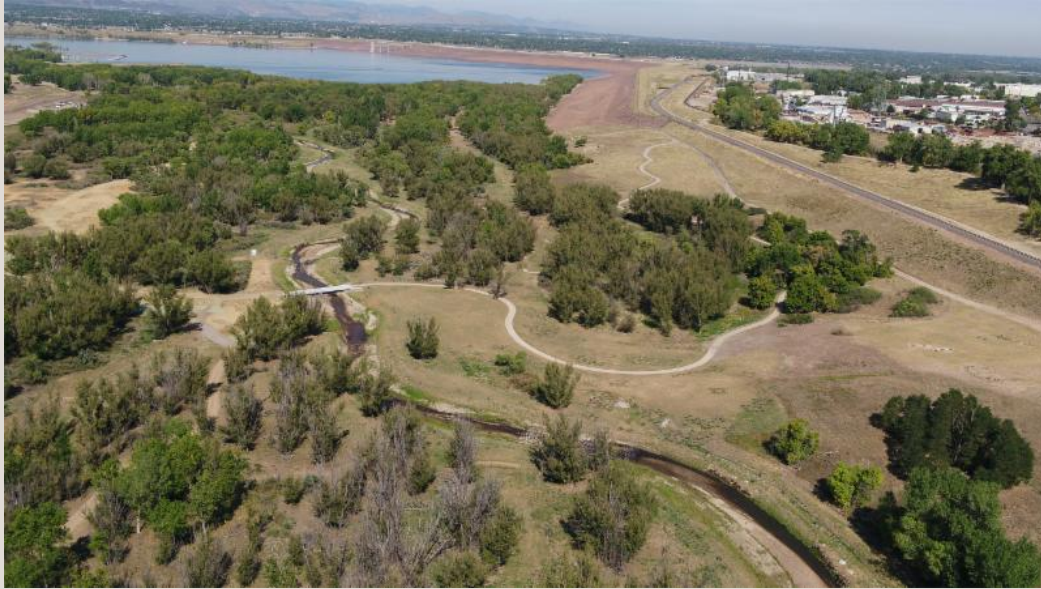
Downstream view of the new Plum Creek Trail connection that provides for the first time a new loop around Chatfield Reservoir.

The Plum Creek Trail, which includes a new bridge crossing, has been constructed within the Plum Creek Nature Area. Through a partnership with Centennial Water and Sanitation District, CSRP was able to complete a new trail connection from the Dam Trail to the new Plum Creek trail system, providing cyclists and recreators the ability to loop around Chatfield Reservoir for the first time. While the new trail system is open from the Dam Trail side, access to the Plum Creek Nature Area from Park's south side won't be established until July 2019.
